# Manhole Inspection Summary

Manhole # S29CC1021MH

Insp Date: **12/12/06 10:12 AM**

**Location** Address: **3643 KESWICK RD**

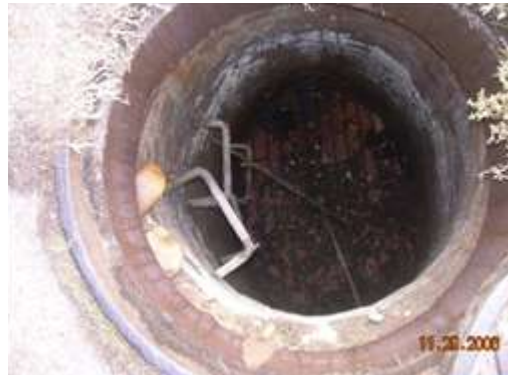
Top View

Frame offset. Adjustment deterioration. loose brick and infiltration. Channel debris.

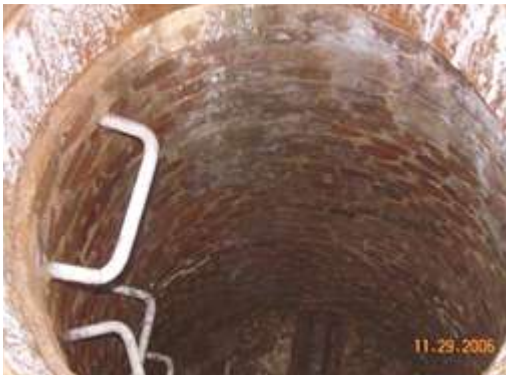
Defect

Adjustment, Corbel and Barrel infiltration.

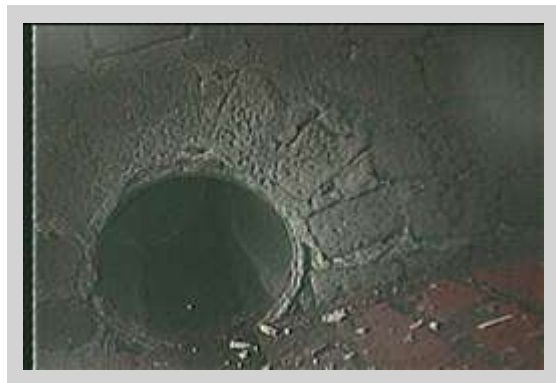
Pipe Out @ 12 O'Clock

8 in. Circular Gravity Sewer

Infiltration: **Evidence**
